JPRS: 24,826

28 May 1964

FATIGUE AND OXIDATION OF HIGH-TEMPERATURE ALLOYS

- USSR -

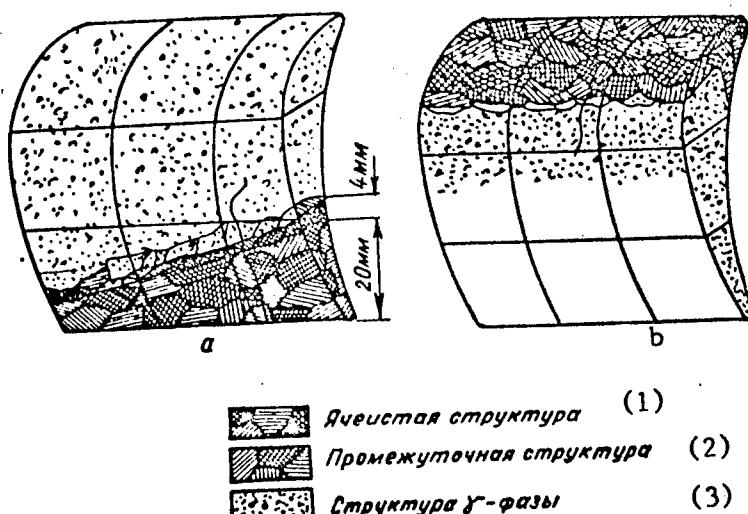
In one vane from the investigated alloy, a deep crack in the trailing edge was observed. Microscopic investigation of this vane showed that the cellular structure was not only close to the cracks but on the entire trailing edge of the vane (Fig. 4a),

Fig. 4. Illustration of the distribution of cellular, intermediate, and γ' -phase structures in: a-- a vane with a crack on the trailing edge, b--a vane after 275 cycles. 1--cellular structure, 2--intermediate structure, and 3--structure of the γ' -phase.

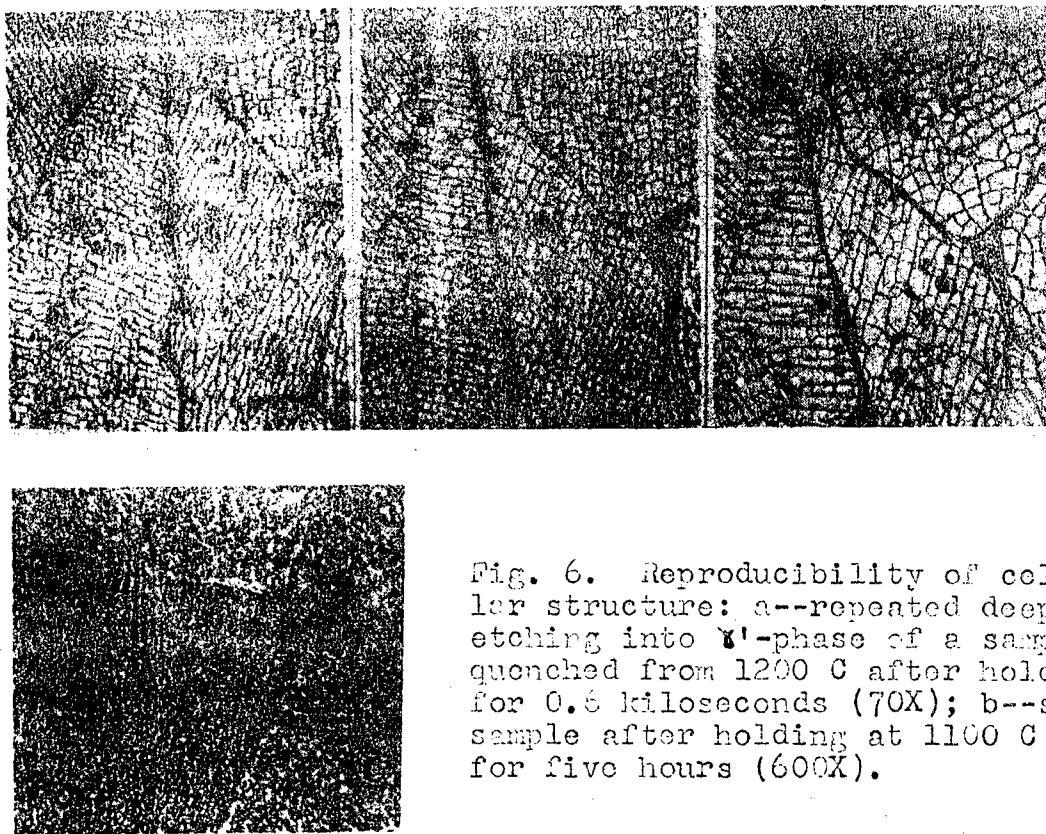
In microstructure analysis appears the question on the fact that there is a cellular structure and is it a result of etching? In the process of investigation many samples were subjected to repeated polishing and etching. In all cases the revealed microstructure was always the same. In addition, as one may see from Fig. 5a, in the surface layers, only the cellular structure is observed. The transition to deeper layers shows that the finely dispersed γ' -phase is revealed on the background of the cellular structure. Internal sections of the polished section always contained precipitated particles of carbides and the γ' -phase. This observation leads to the conclusion that the cellular structure may be associated with a causal effect of etching.

Fig. 6. Reproducibility of cellular structure: a--repeated deep etching into δ' -phase of a sample quenched from 1200 C after holding for 0.5 kiloseconds (70X); b--same sample after holding at 1100 C for five hours (600X).

Special tests were carried out to explain the nature of the cellular structure. Samples with a cellular structure were subjected to repolishing and etching many times. In Fig. 6a, microphotographs are shown of the same polished section after repeated polishings. As evident, in all cases the nature of cell orientation is preserved, although cell size is changed. Preservation of cell orientation after repolishing in the confines of one grain and its change in the transition to another grain serves as an indication that the cellular structure reflects crystallographic orientation of the grains. However, change of cell size places identity of structure and substrate in doubt.

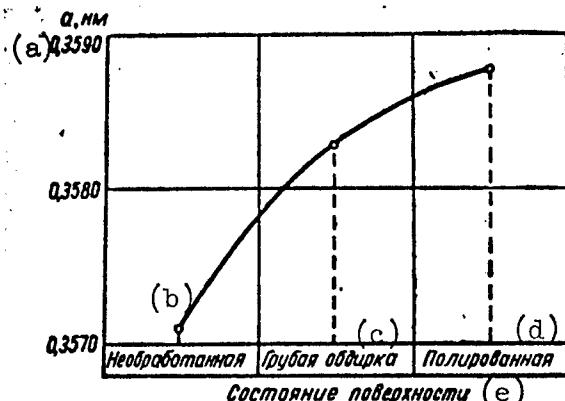
Results of measuring the lattice parameter of the γ -phase in the region of possible crack formation (middle of leading edge on concave side) in vanes are presented in Fig. 1.

Fig. 1. Curve of the change of lattice parameter of the γ -phase on surface of vane to stage of mechanical working: a--lattice parameter a, nm; b--unmachined; c--deep roughing; d--polishing; e--distance from surface.

From Fig. 1 it is evident that machine leads to some increase in lattice parameter. These results are explained in that, during casting and heat treating, layers are formed on the surface which differ in composition from the ZhS-6K alloy, and upon further roughing and polishing these layers are removed. This explanation is verified by a change in the lattice parameter after etching of unmachined and polished vanes at various depths. For example, when etching and unmachined vane the following results are obtained:

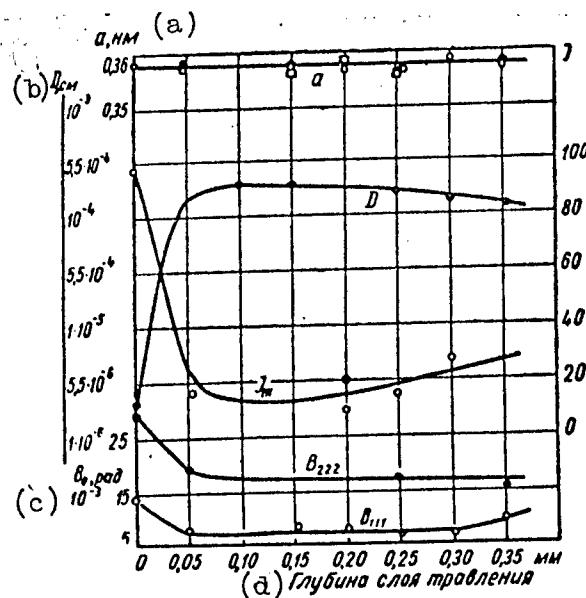
Results of x-ray examination of the surface layer of a polished vane with respect to depth of etching are shown in Fig. 2. As one can see, in etching the finished surface of a vane, the γ -phase parameter remains almost unchanged. Thus,

roughing and polished of the surface completely removes the layer of variable composition which is formed during pouring (casting) and heat treatment of the vane.

Fig. 2. Curves of the change in line widths (B_{111} and B_{222}), integral intensity of line 111 (I_{111}), lattice parameter, and size of the region of coherent scattering of the δ -phase according to depth of the surface layer in a vane: a--lattice parameter a , nm; b--depth D , cm; c-- B_0 ; d--depth of etched layer.

From Fig. 2 one may conclude that the thickness and structure of the cold-worked surface layer, which is important in this case, have a decided effect on resistance to thermal fatigue [57]. These data obtained in filming the concave region of the vane along the leading edge show that the width of lines (111) and (222) and the intensity of line (111) are changed up to a depth of 0.1 mm from the vane surface, i. e. the depth of the cold-worked layer is approximately 0.0-0.1 mm deep. Size of the region of coherent scattering and magnitude of micro-distortions on the surface of the vane were determined from widths of lines (111) and (222) and found to be $\Delta a/a \approx 2.7 \times 10^{-3}$ and $D \approx 3 \times 10^{-6}$ cm respectively. From modeled presentations developed in [9-11] it follows that distribution of dislocations on the surface of a finished vane is random. Even at a depth of approximately 0.05 mm microdeformations are practically zero and the size of the blocks of coherent scattering exceed 1×10^{-4} cm. Deeper in the vanes the size of these blocks does not change.

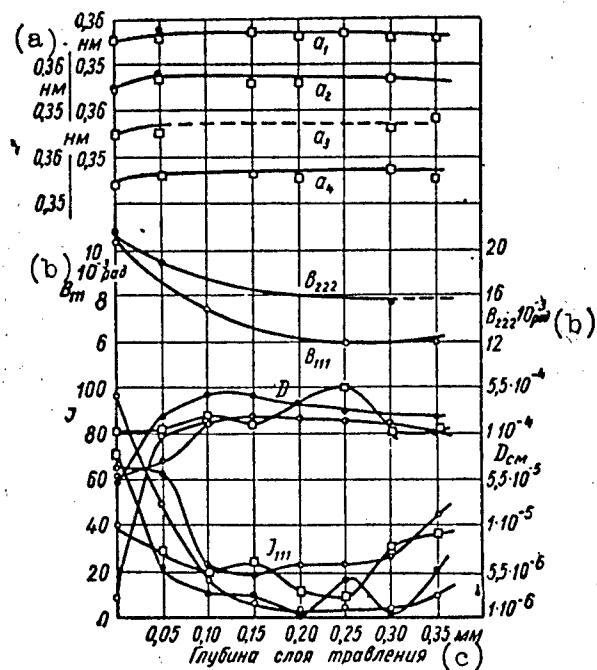
A vane was similarly investigated at 650 cycles (without cracks) according to mode 1 (page 14). Results of this study are presented in Fig. 3. X-ray photographs were taken at four regions of the vane surface: 1) the region of the leading edge on the concave side (parameters-- a_1 , I_{111} , and D --○; 2) region of the leading edge on concave side (parameters-- a_2 , I_{111} , and D --●; 3) concave region in center section (parameter -- a_3 , I_{111} , and D --□; 4) back side in center (parameter-- a_4 , I_{111} , and D --■).

Fig. 3. Characteristics of crystal structure of vane surface layer after 650 cycles: a--nm, b--radians, c--depth of etched layer

Lines widths on graph are for those regions on the leading edge, concave side.

Thus, all structure changes, accumulated as the result of thermal cycling, are concentrated primarily in the fine surface layer with a thickness of 0.05-0.10 mm.

Judging by the intensity of lines (111) it is interesting to note that the size of the regions of coherent scattering is smallest ($\sim 10^{-6}$ cm) in the zone where cracks had been previously noted (on the leading edge, concave side). The same order of block dimensions ($\sim 3 \times 10^{-6}$ cm) gives an estimate as to widths of lines (111) and (222). In other zones the size of the regions of coherent scattering are much larger.

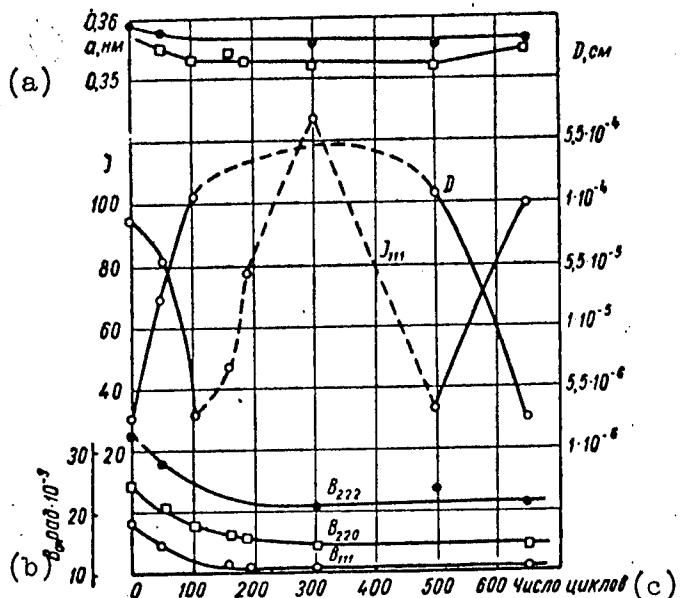
Fig. 4. Effect of the number of thermal cycles on characteristics of the crystal structure of the δ -phase (variant 1): a--lattice parameter-a, nm; b--radians; c--number of cycles.

In spite of the small size of the blocks in the zone of the leading edge (it is the same as in the initial unmachined vane), microdeformations of the δ -phase lattice are not observed. This fact can be explained principally by the varying distributions of dislocations in the surface layers of the original vane and vanes subjected to 650 cycles. The produced result fully agrees with the result of work [47].

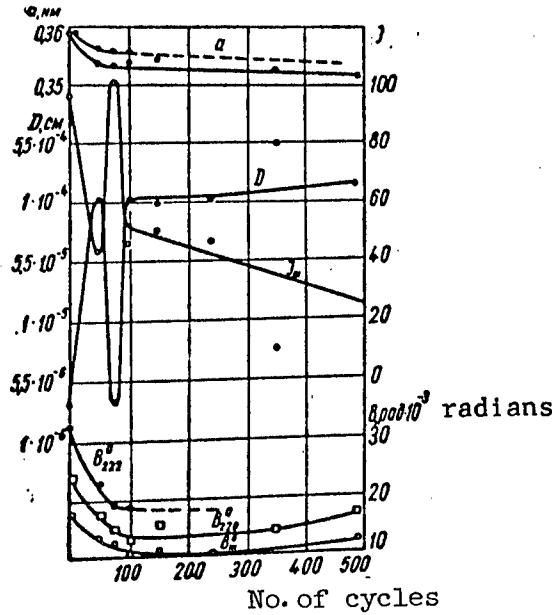
It must be noted that the above-described regularity of structure changes, depending upon number of thermal cycles, were confirmed by an investigation of other batches of vanes which were tested according to mode 2. Results of these investigations are presented in Fig. 5. The vanes of this batch began cracking at 100 cycles (in Fig. 5., vanes with cracks are marked below with arrows). As in the preceding case, lines are completely narrowed at 100 cycles. At this point the change of lattice parameter of the Y-phase is completed.

Fig. 5. Effect of number of thermal cycles on properties of the γ -phase crystal structure (variant 2).

Size of blocks in the danger zone is increased at first (at 50 cycles it is close to 1×10^{-3} mm and then sharply decreases to the point where at 75 cycles the size is approximately 3×10^{-6} mm), after which follows crack formation. After crack formation blocks in regions adjacent to the cracks become larger indicating the predominant effect of temperature in forming of structure; the fact of breaking up of blocks before disturbing material structure agrees with the results of work [12] in which thermal fatigue of pure copper was studied.

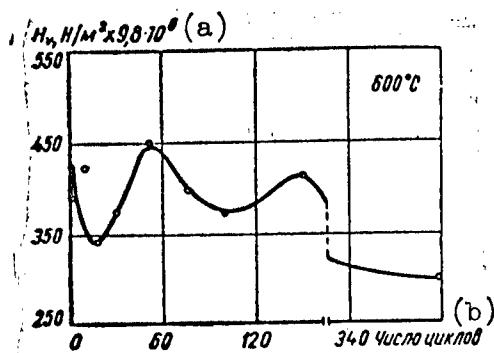
Hot hardness data are given in Fig. 1. The curve represent change of hardness with respect to number of cycles. As can be seen, the curve has an erratic nature. However, the first minimum and maximum points on the curve coincided for all temperatures. This testifies to the fact that change of hardness during thermal cycling is not manifested by thermal stresses but by changes in the fine crystal structure of the alloy.

Fig. 1. Change of hardness with respect to number of cycles in alloy ZhS-6K:
a--Vickers hardness, N/mm^2 ;
b--number of cycles.

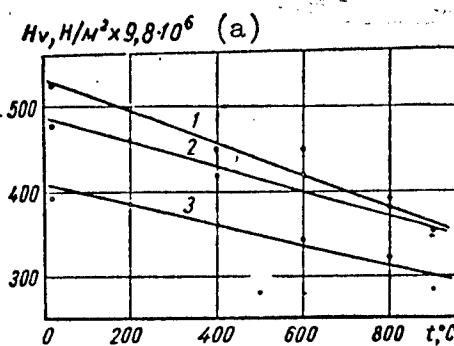
Fig. 2 shows the relationship of the magnitudes of the minimums, maximums and initial hardness taken from curves similar to that in Fig. 1.

Fig. 2 Relationships of magnitudes of minimums, maximums and initial hardness: 1--initial hardness, 2--hardness of first maximum, 3--hardness of first minimum; a--Vickers hardness, N/mm^2 .

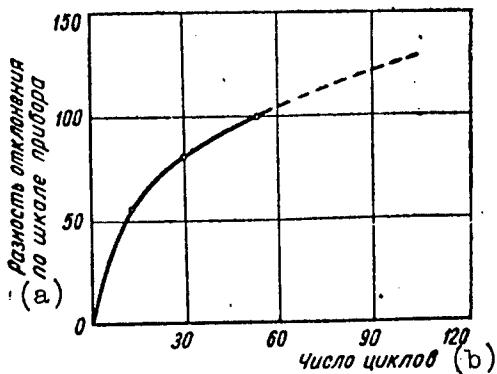
Fig. 3 shows the change of eddy current loss as a function of number of thermal cycles in a ZhS-6K sample cycled at 1000 °C and air cooled. From this study it was established that there is an increase in eddy current loss which may be associated with diminished electrical resistivity of the surface layer. However, the cause of the latter phenomenon is still unclear.

Fig. 3. Curve of change in eddy current loss as a function of number of cycles: a--difference in deflection of instrument; b--number of cycles.

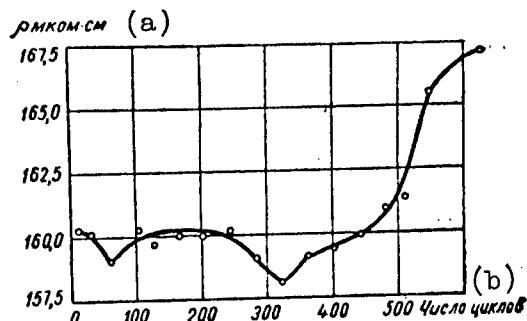
A typical curve for change of resistivity with respect to number of thermal cycles is shown in Fig. 4, from which it is evident that in the initial stages ρ is decreased (up to 50 cycles). A second minimum is observed in the region of 300-350 cycles after which resistivity is continuously increased up to 600 cycles. As mentioned above, the curve of resistivity as a function of number of cycles is the result of the applied effect of two factors: 1) change of structure associated with change of stresses and block sizes and 2) change

of phase quantity and composition in the alloy. Nence, in order to understand processes which cause the produced relationship of resistivity to number of cycles it was necessary to compile the results of investigations by other methods along with this investigation. The study of paramagnetic susceptibility showed that in thermal cycling there is a continuous increase of susceptibility which denotes the continuous depletion of the matrix solid solution. The subsequent rise and plateau region of the curve can be understood by comparing the resistivity function with the hot hardness curve. In the same interval of cycles, a hot hardness peak is observed which apparently corresponds to reduced block dimensions. Consequen-
tly, in this interval the path of the resistivity curve is concurrent upon two factors: further depletion of the solid solu-
tion causing a lowering of resistivity, and breaking up of the mosaic blocks which then leads to an increase in resistivity.

Fig. 4. Function of resistivity to number of cycles: a-- ρ , microohms-cm; b--number of cycles.

The sharp rise of resistivity after 300 cycles is difficult to explain and can only be approached by comparison of hot hardness and paramagnetic susceptibility. For a precise explanation of these processes it will be necessary to find new methods using both structure sensitive properties and those properties which depend only on phase composition.

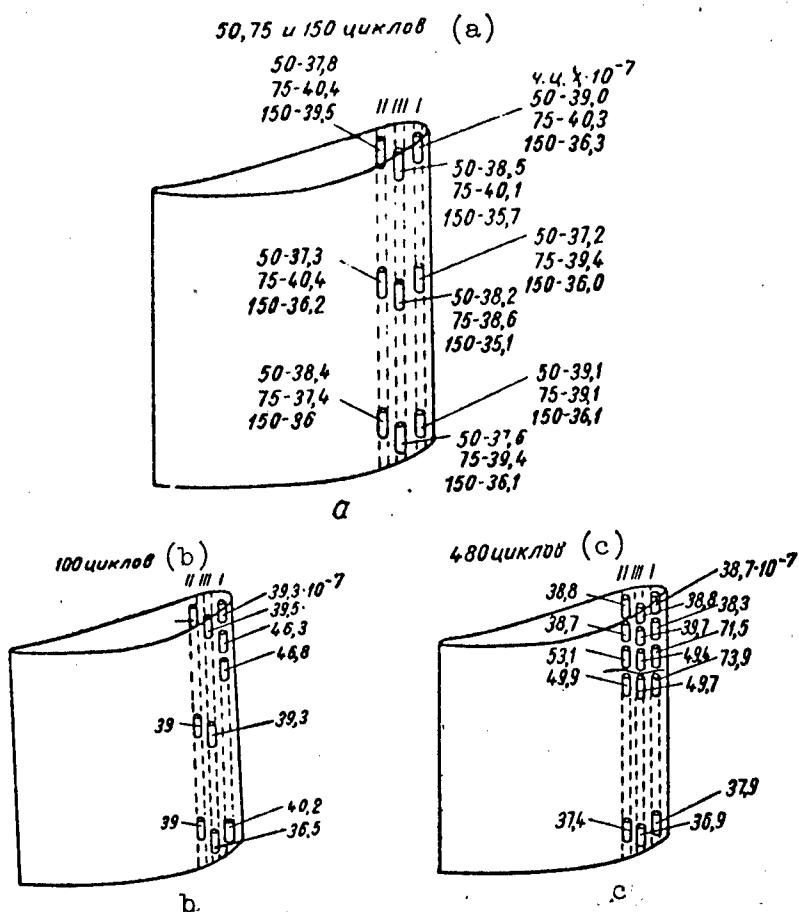
ments, is formed. Under these conditions, formation of cracks is more probable. Consequently, to study crack formation it is necessary to measure susceptibility very close to the cracks. Therefore, if cracks were observed in the vane, samples, besides those illustrated in Fig. 6, were also cut from sections adjacent to the crack.

Fig. 6. Paramagnetic susceptibility at various points of a vane for different number of cycles: a--50, 75, and 150 cycles; b--100 cycles; c--480 cycles.

Vanes made from the material of one heat were studied after stand testing for 50, 75, 100, 150, 240, 350 and 480 cycles. In this case, cracks of different magnitude were observed in vanes after 100, 240, 350, and 480 thermal cycles. Measurements showed that the same regularity of change in sus-

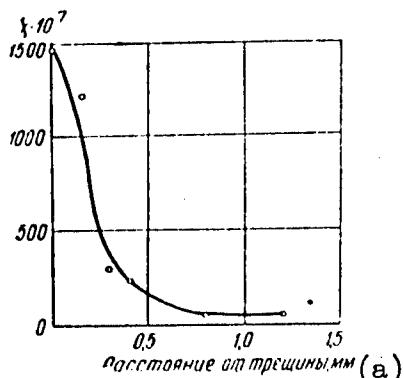
Fig. 7. Curve of the distribution of paramagnetic susceptibility to depth of sample: a--distance from crack, mm.
